CASE STUDY

HANNIBAL & NIXA CLARIFIER REHABILITATION PROJECTS

Midwest Infrastructure Coatings (MIC), an OBIC-certified installer, completed two major clarifier rehabilitation projects across Missouri: one restoring a severely corroded 30-year-old structure and the other setting a record as the largest exterior clarifier coated in OBIC's history.

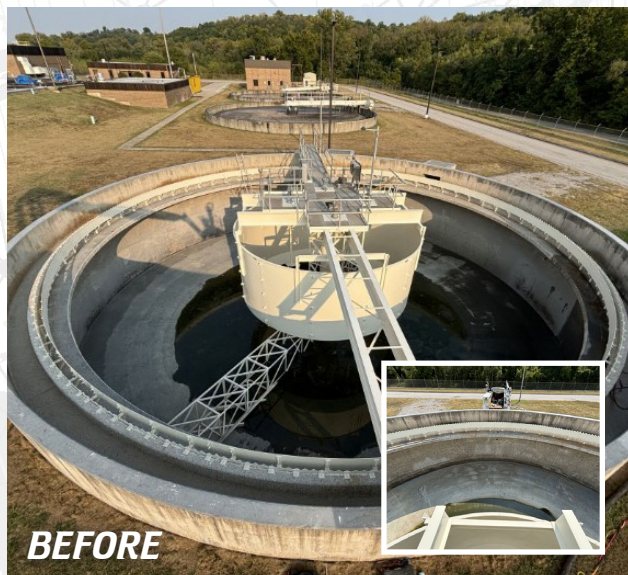
BEFORE

In Hannibal, the 7,000-square-foot clarifier had been in continuous service for over 30 years, with hydrogen sulfide (H₂S) corrosion eroding the concrete to the point that the aggregate was exposed.

The MIC crew began by having the clarifier surface sandblasted to remove decades of buildup and prepare for coating. Then, they applied OBIC 1000 polyurea at 100 mils thick to the clarifier walls and launder section, using OBIC 1306 structural foam to fill and stabilize a damaged area near the launder.

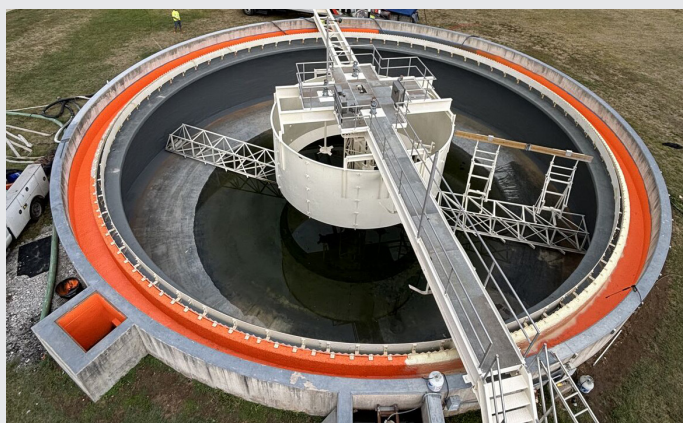
In Nixa, a 20-year-old clarifier needed rehabilitation before more serious structural issues developed. The structure, spanning 16,700 square feet, represented the largest exterior clarifier ever coated with OBIC, a milestone for both OBIC and MIC.
