# CASE STUDY

VIRGIL GRISSOM MIDDLE SCHOOL PACKAGE PLANT LINING

### **OVERVIEW:**

In order to prevent spending millions of dollars to replace the aging steel package plant structure located behind the school, OBIC products were used to line and stop the active inflow and infiltration.

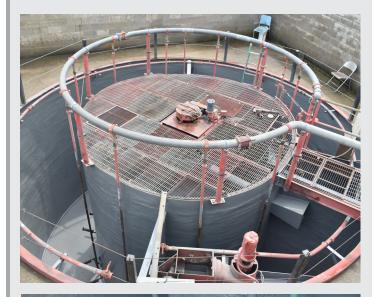
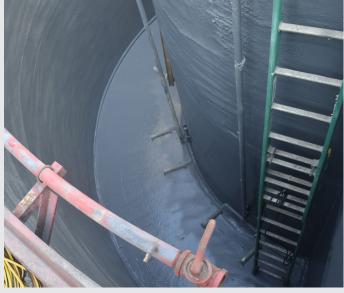
Groundwater was leaking into the aging steel package plant structure used to treat the middle school's wastewater. The customer was facing a situation where if they had to replace it with a new one, they would have to acquire land and the relevant permits for it, build a new package plant, dig out a place for the new structure, and pour concrete, with the total replacement cost rising upwards to millions of dollars. The customer sought a solution that would prevent the heavy cost and time expense of replacement.

ART started the prep work with sandblasting the package plant. Since it was located right beside the school, they opted to use a wet blast using glass media with a rust inhibitor to decrease the amount of debris coming from the sandblasting. To stop the active leaks, they drilled holes in the steel and injected OBIC's chemical grout 2262. They also installed steel plate patches on some of the larger holes while lining the structure. After the package plant interior was rinsed, they removed all liquids and media with a VAC truck and primed it with OBIC 1503.

The OBIC Armor system was then carefully applied in a grey color to closely match the steel underneath. OBIC's three-layer system known as OBIC Armor is composed of a 50-mil thick first adhesion layer of OBIC 1000 polyurea, a 400-mil thick layer of OBIC 1306 high-density polyurethane foam, and a 50-mil thick moisture barrier layer of OBIC 1000. This creates a 500-mil thick coating that provides chemical protection, leak protection, and structural support.
