## ***CASE STUDY***

WHEATLAND WASTEWATER SYSTEM REHABILITATION

Wheatland, Missouri

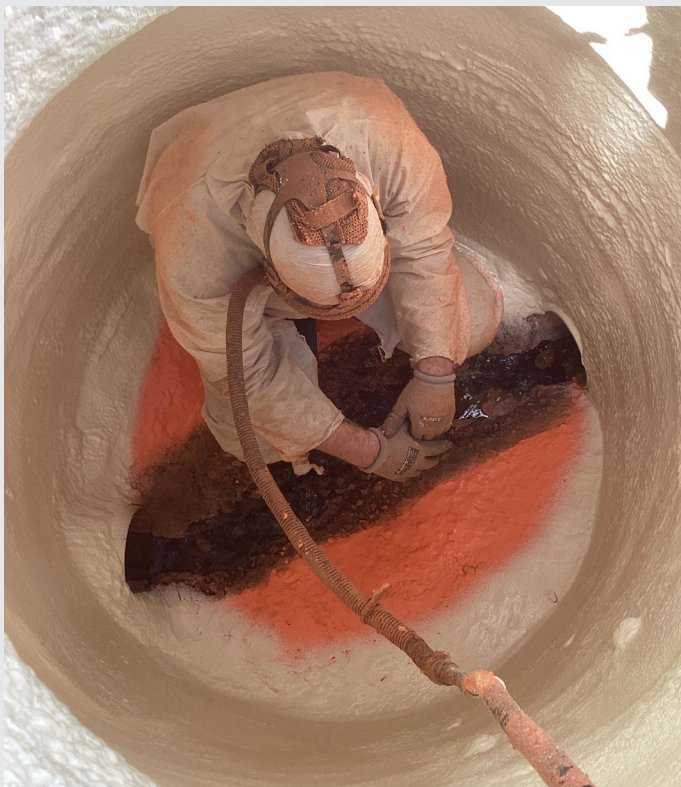
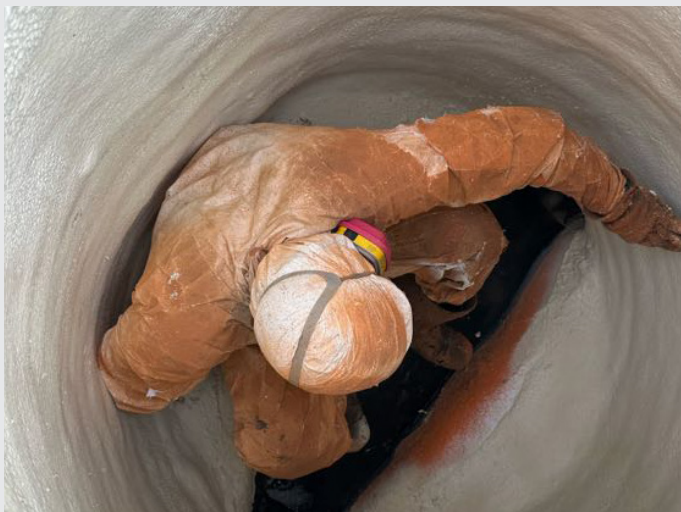
The City of Wheatland, Missouri, was facing severe inflow and infiltration (I&I) issues that strained its wastewater system and compromised lagoon performance. Aging infrastructure and limited resources made comprehensive repair seem out of reach, until federal ARPA funding provided a rare opportunity to act.

- Rehabilitated 260 manholes, all but two in the city
- Lined approximately 1,100 vertical feet of manhole surface
- Repaired the main lift station, six feet in diameter and 20 feet deep

To stop groundwater infiltration, eliminate leaks, and extend the life of the concrete and brick structures, OBIC Armor Multi-Layer System was applied:

- OBIC 1000 Polyurea Base Layer provided superior adhesion and moisture sealing.
- OBIC 1306 Polyurethane Foam Layer added structural support and durability.
- OBIC 1000 Topcoat delivered a seamless, corrosion-resistant finish.
